DAM REHABILITATION: DEWATERING & EXCAVATION SUPPORT

Bear Creek Dam Russellville, Alabama

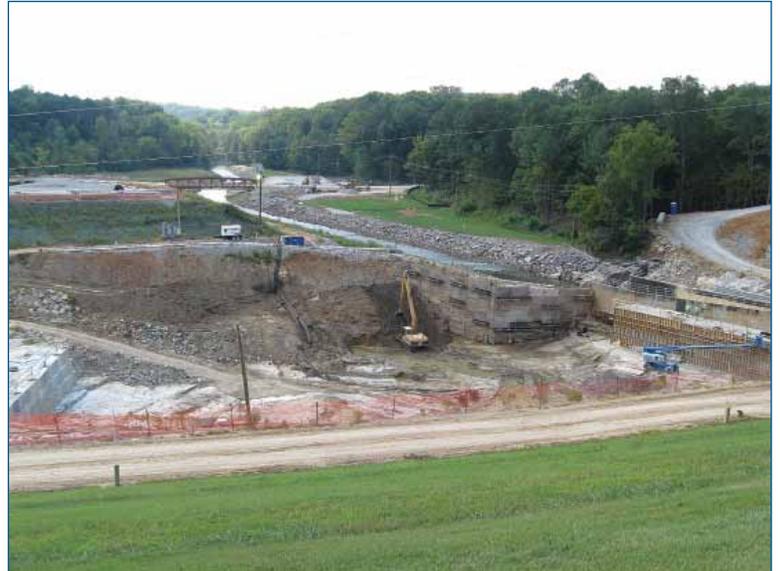
Top: Remediation of Bear Creek Dam involved excavation for the construction of a roller compacted structure at the toe of the existing dam.

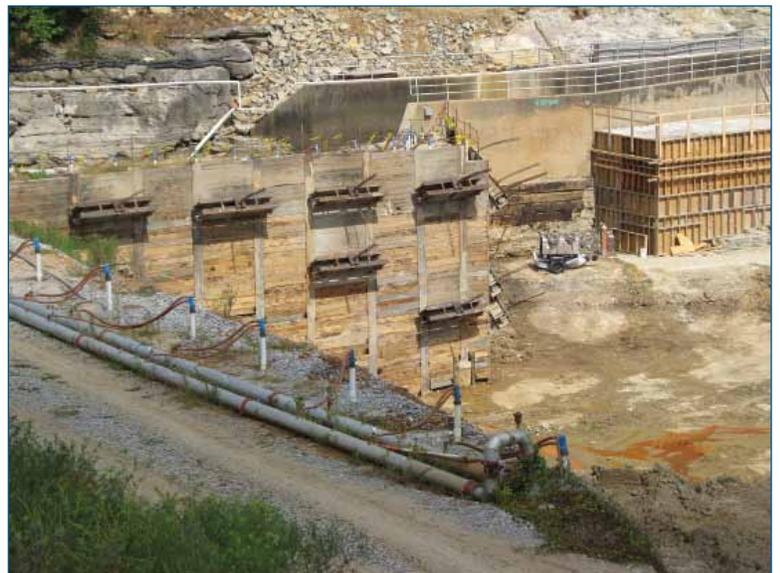
Above: Moretrench performed construction dewatering (eductor system shown in foreground) and excavation support during the remediation program.

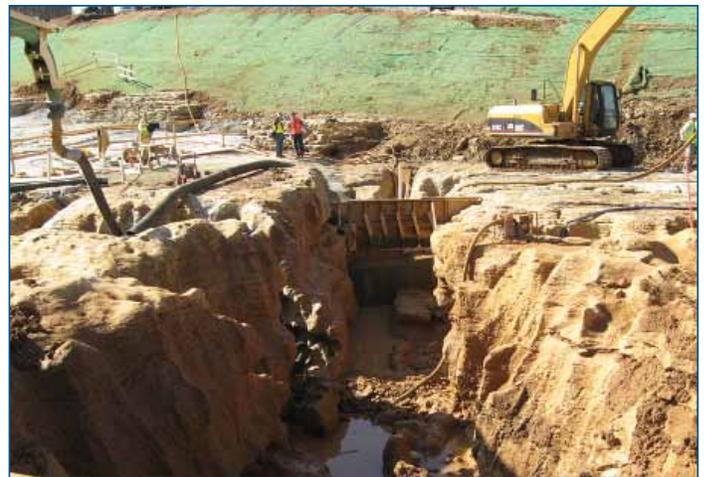
Above: During excavation, large fractures in the limestone rock were unearthed that were cleaned and filled with mass concrete by the TVA.

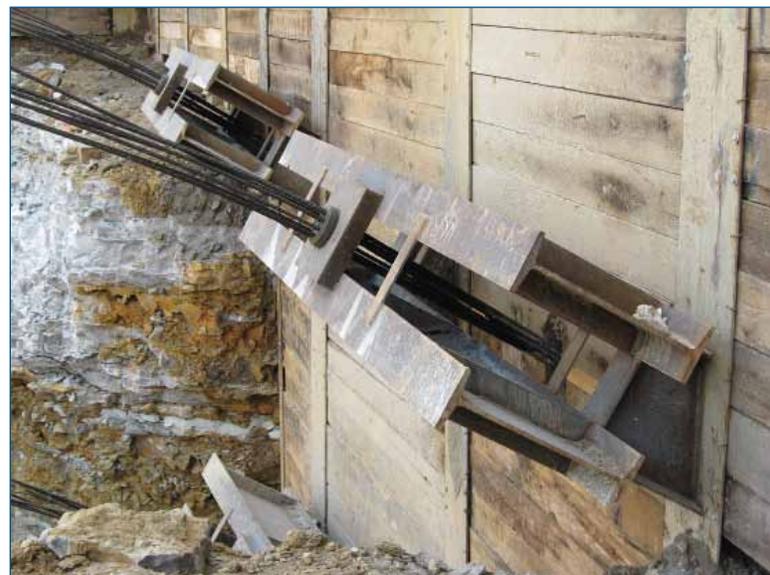
Above: Installation of post-tensioned, multi-strand rock anchors provided the additional lateral restraint needed to withstand the wall loading.

Additional lateral wall restraint was provided by a total of 27, post-tensioned stranded anchors installed through previously welded-in-place walers and bonded in the underlying rock formation. Anchor design loads ranged from 105 to a maximum of 316 kips. Performance testing to 133% of design capacity was conducted on five spillway and two sluiceway anchors and the remainder proof-tested.
