## ► PROJECT SUMMARY Ground Freezing

## Access Shaft #3 Sistema de Potabilización Area Norte Provincia de Buenos Aires, Argentina

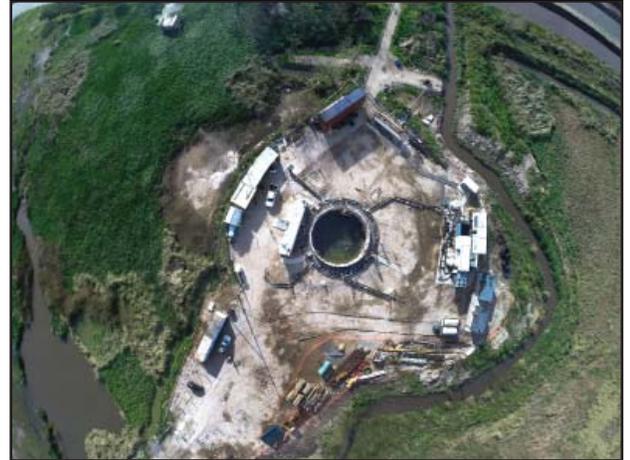
► Aerial view of Shaft #3 showing perimeter ground freezing system.

All ground freezing equipment, including pipes, fittings, tanks, instrumentation and data acquisition system, and two mobile freeze plants with a combined refrigeration capacity of 281 tons, was shipped from Moretrench's New Jersey headquarters. The installed system consisted of 48 vertical freeze pipes around the shaft perimeter, 25 angled freeze pipes installed around and beneath the tunnel, and seven temperature monitoring pipes. Freeze pipes consisted of 4.5-inch OD steel pipe terminating in the hard clay layer.

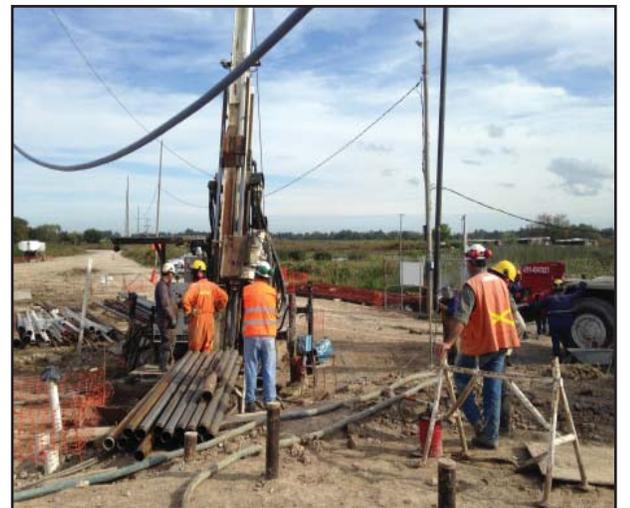
► Drilling underway for freeze pipe installation.

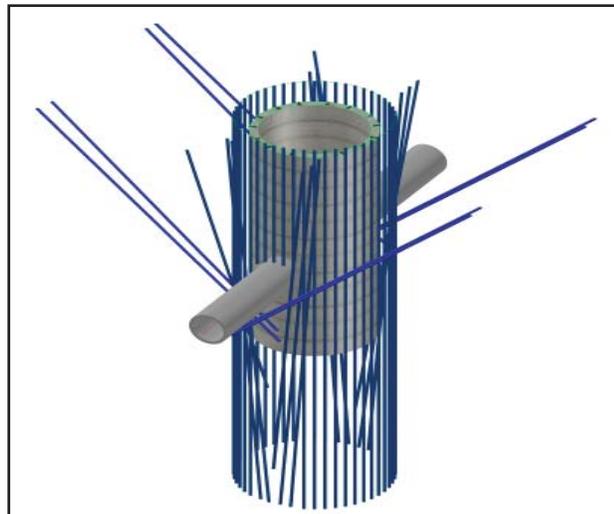
► Freeze pipe layout around existing shaft and tunnel.

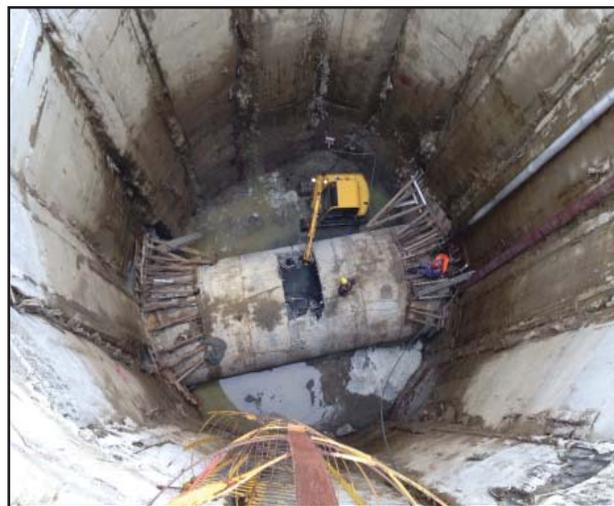
► Removal of the portion of the tunnel within the shaft prior to installation of the final concrete liner.
