JET GROUTING

First Morris Bank Morristown, New Jersey

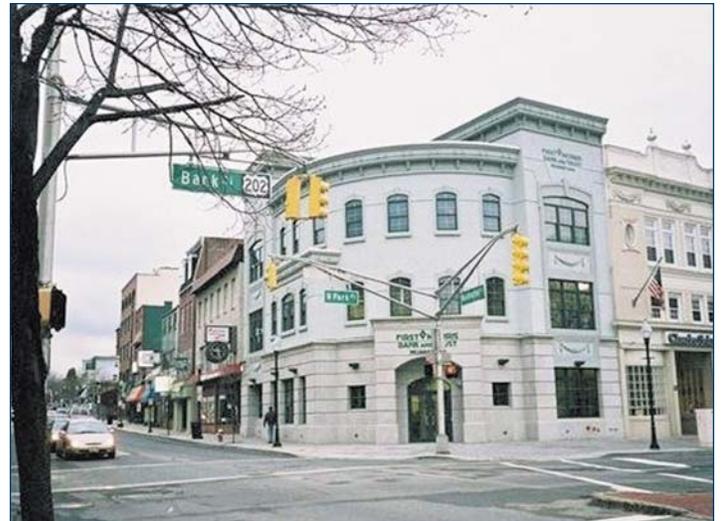
Top: Jet grouting provided structural underpinning for two adjacent buildings bearing on very loose sands during construction of this new, 3-story bank branch.

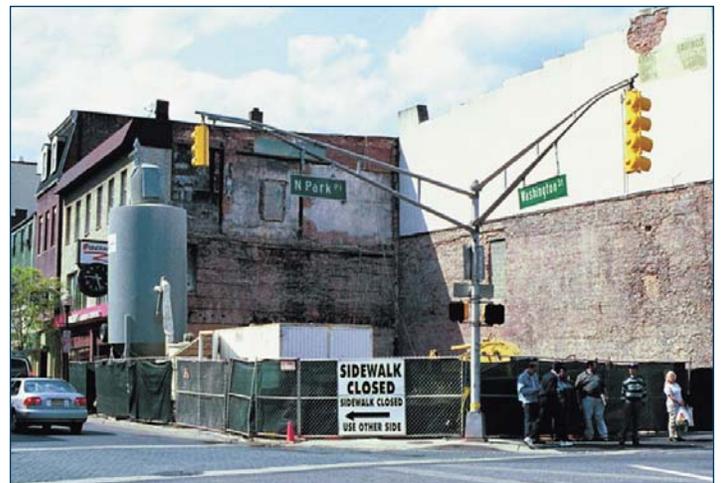
Above: Space limitations dictated a separate staging area adjacent to the site for the grouting equipment.

Moretrench accomplished the jet grouting from the top of the footing elevations to be underpinned. Due to space restrictions in the immediate work zone, a separate staging area was set up adjacent to the site for the jet grouting equipment.

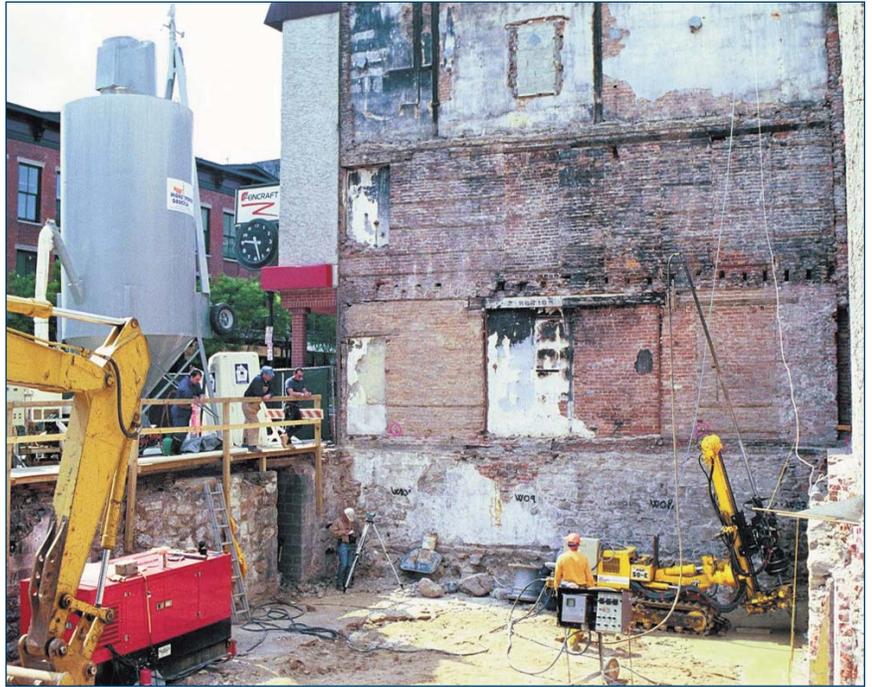
Jet grouting was accomplished from the top of the footings to be underpinned.

Two and three rows of interconnected, vertical and inclined jet grout columns were installed at two feet on center from top of rock up to the underside of the building footings. Installation was sequenced to allow the soil-cement matrix to set up before construction of adjacent columns. Spoil created by jet grouting operations was allowed to solidify and removed daily by a service backhoe. One hundred and eighteen vertical and inclined columns were installed, for a total jet grouting length of 1008 feet.
